# Manhole Inspection Summary

Manhole # S41A\_\_021MH

Insp Date: **11/14/08 12:35 PM**

**Location** Address: **1255 pearleaf ct** Cross Street: **n central ave**

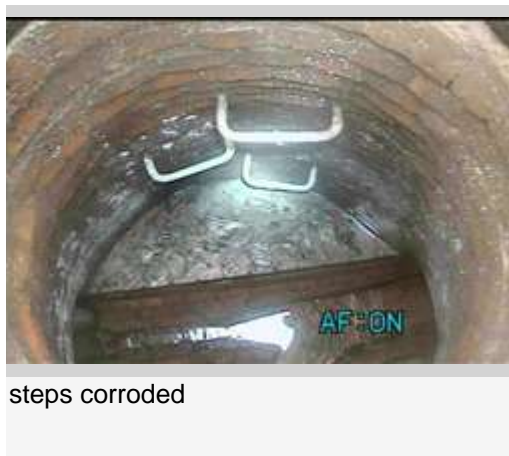
Defect 1

**Steps** Count: **3** Missing: **0** ☒ **Corroded**

steps corroded

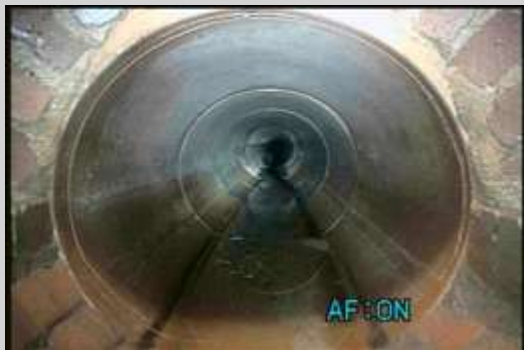
12 O'Clock Outflow

18 in. Circular Gravity Sewer  
Pipe Out @ 12 O'Clock

Pipe Material: **Clay** ☐ Pipe Lined

Invert Depth: **7.75** (ft.) Flow Characteristics: **None**

Deposits: ☒ None ☐ Mud ☐ Sludge ☐ Debris ☐ Grease

Infiltration: **None** Pipe Seal Cond: **Unknown**

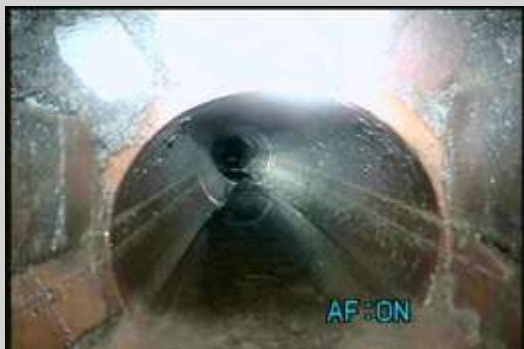
3 O'Clock Inflow

10 in. Circular Gravity Sewer  
Pipe In @ 3 O'Clock

Pipe Material: **Clay** ☐ Pipe Lined

Invert Depth: **7.41** (ft.) Flow Characteristics: **None**

Deposits: ☒ None ☐ Mud ☐ Sludge ☐ Debris ☐ Grease

Infiltration: **None** Pipe Seal Cond: **Unknown**

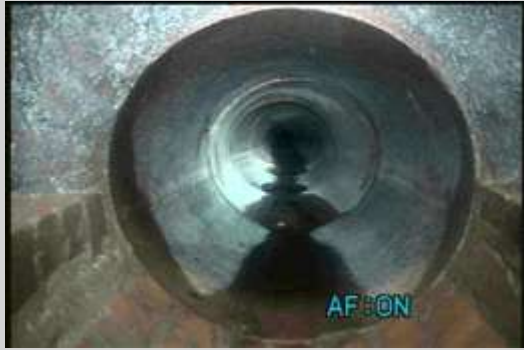
6 O'Clock Inflow

18 in. Circular Gravity Sewer  
Pipe In @ 6 O'Clock

Pipe Material: **Clay** ☐ Pipe Lined

Invert Depth: **7.66** (ft.) Flow Characteristics: **None**

Deposits: ☒ None ☐ Mud ☐ Sludge ☐ Debris ☐ Grease

Infiltration: **None** Pipe Seal Cond: **Unknown**
